HSSE LESSON LEARNT

WRIST AND NECK PAIN DUE TO IMPROPER POSTURE

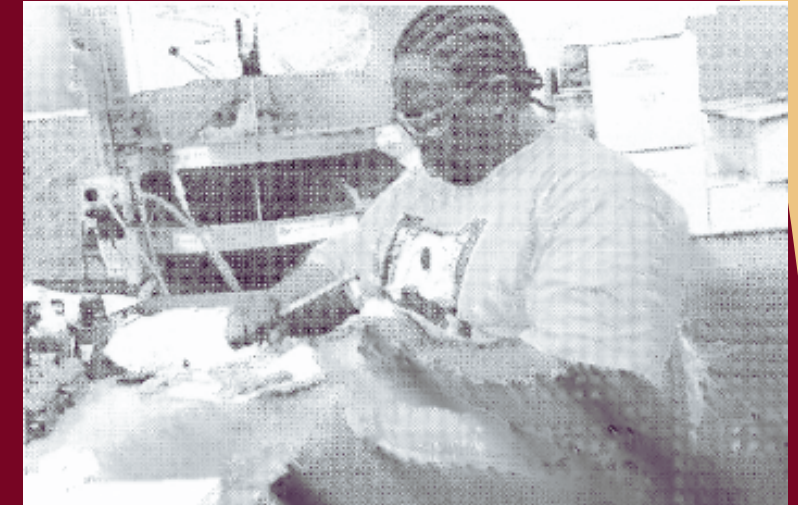
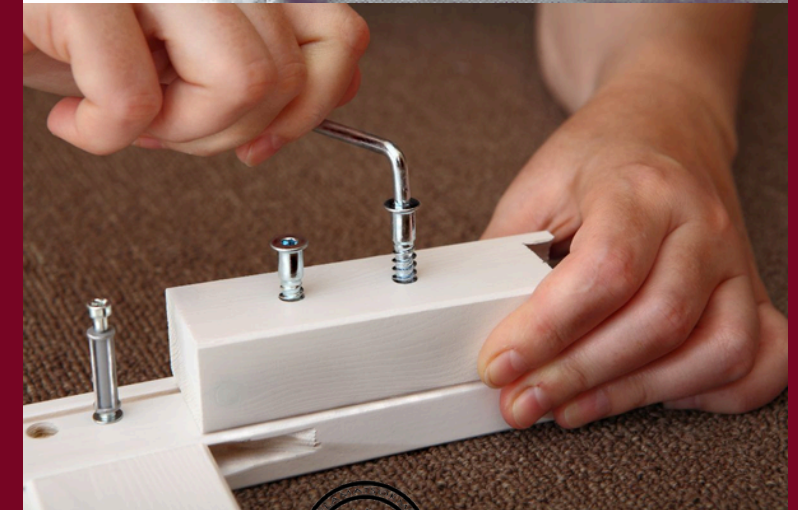
An employee in a shop floor facility uses a combination of an Allan wrench and power wrench to insert several hex screws. When interviewed, the worker explained that he used the power tool to insert the hex screws to a determined position. Afterwards, he finished the insertion using the Allan wrench with a determined torque. This task causes the worker much wrist and elbow movement combined with the repetitive nature of the task. The Rapid Upper Limb Assessment (RULA) model was applied to this posture; the results indicate that changes are required soon. Specifically, of concern are the wrists position and its repetitive movement, and the posture of the neck.

- Repetitive nature of the task
- Improper posture of the neck
- Vibration of power hand tool
- Excessive exertion of a sustained force on a hard surface

- Design handles that make use of the maximum strength capability of the hand by featuring a power or oblique grip involving the palm.
- Reduce the vibration from a powered hand tool, such as an electric drill as far as this is practical.
- Design tools to reduce the need to exert a sustained force on a cold and hard surface.
